**RESERVE FUND REPORT  
FOR  
RENAISSANCE PLACE  
EDMONTON, AB  
JANUARY 2021**

Board of Directors  
Renaissance Place Condominium Association,  
9918 – 101 Street,  
Edmonton, AB

January 21, 2021

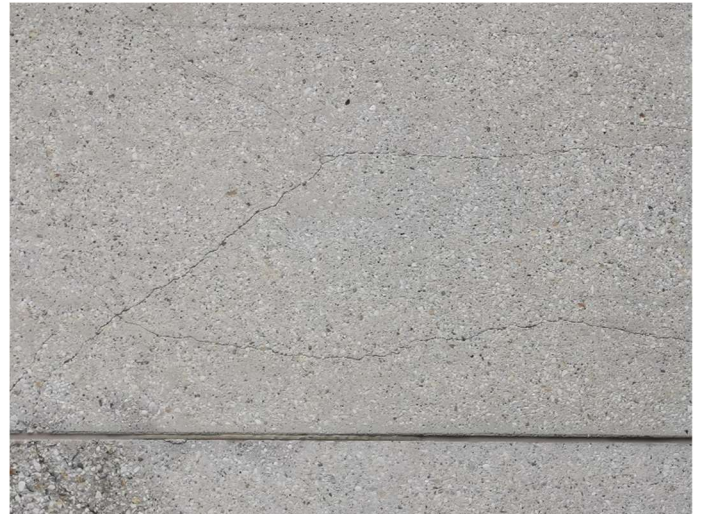
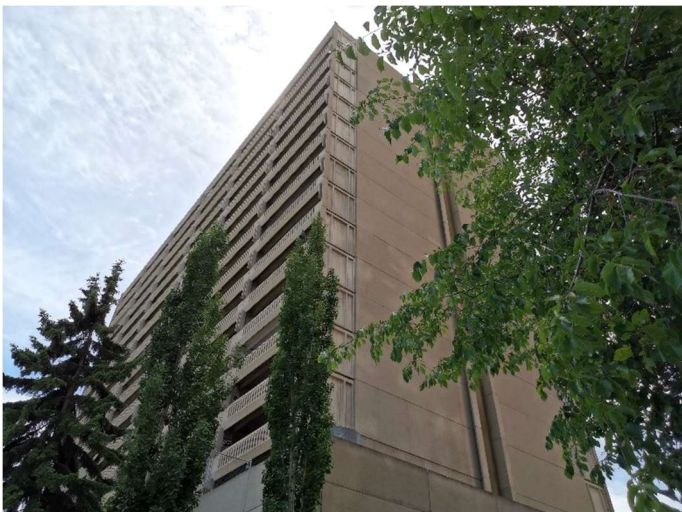
- **Building Envelope** – It was reported that minor cracking in the building envelope curtain walls was observed. The architect who designed the building has been contacted to survey the envelope and make initial recommendations if needed.

Views of Cracks in Building Envelope (East)

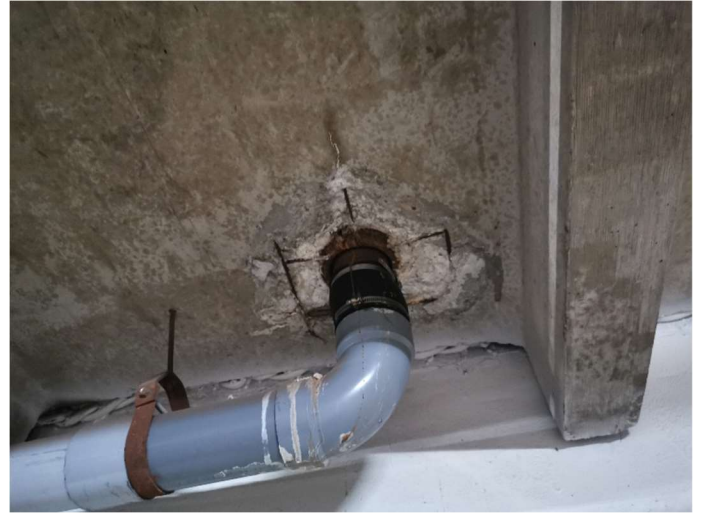
Parkade: Views of Previous Damaged Areas

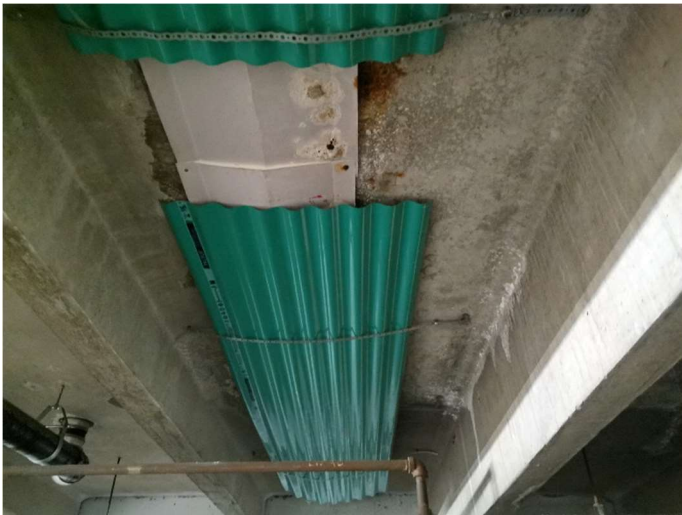
It was reported that there is currently a leak into the parkade from the hot tub, which is to be repaired soon. It was also reported that there is water infiltration from the front and rear building ledges into the parkade and onto vehicles. There is no allocation for this item yet, and the scope and cost to repair are not yet known. No allocation to the cash flow forecast has been made for these items at this time, as it is presumed that these may be repaired as part of operations and the parkade budget (see above).

Leak in Parkade from Hot Tub

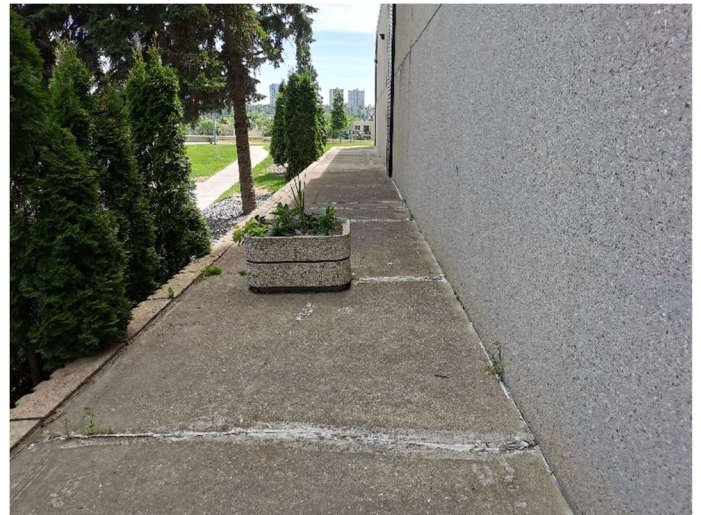
- **Foundation & Parkade** – The foundation and parkade has received repairs over the last several years. The worst areas have been repaired and now the parkade is routinely monitored and repaired. Further repairs will still be required going forward, given the age of the property and the condition of the parkade.

Parkade: View of Past Repairs

Given the age of the parkade and the need for continual repairs, an annual budget of \$50,000 is likely insufficient to catch up and maintain condition of the parkade and foundation. An annual budget of \$110,000 has been allocated under Foundation & Parkade. This would equate to a budget of \$5,000 per stall every 12 years. Given that there has been a relatively lack of past maintenance until recent years, an increased budget for concrete repairs would be prudent. This budget could and should be periodically reviewed for sufficiency.

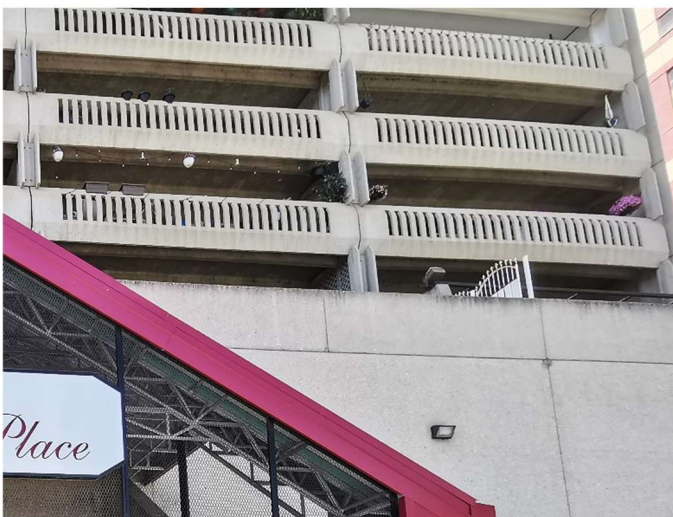
- **Roof** – It was reported that there is a leak in the roof beside the pool facility, which is to be repaired soon. No allocation to the cash flow forecast has been made for this item at this time, as it is presumed that this may be repaired as part of operations and the parkade budget (please see above under Foundation & Parkade).

View of Leak in Roof of Pool Facility

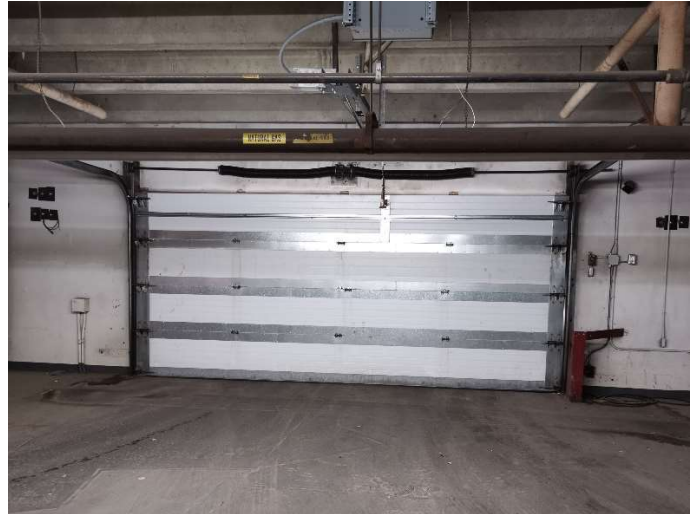
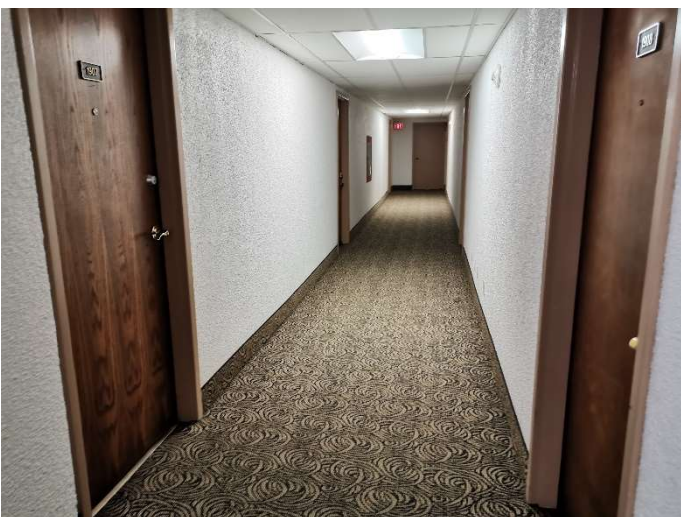
Views of Parkade Doors

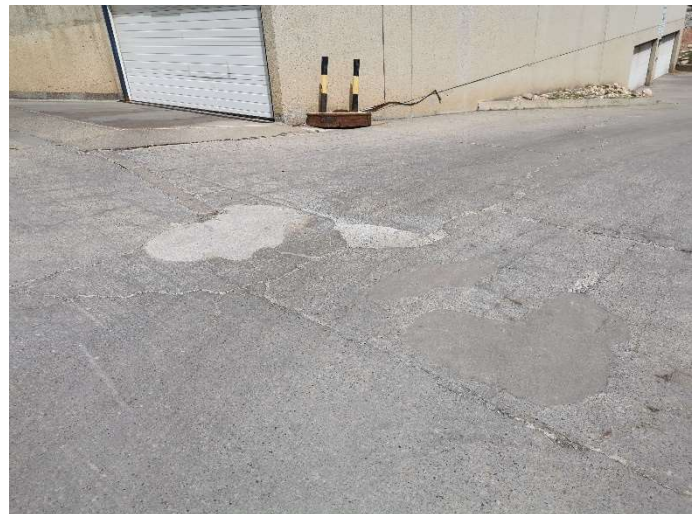
- **Parking Ramp Heating System** – The south parkade ramp is equipped with a heating system to prevent ice formation, and it has been non-functional for a number of years.
- **Exercise Room** – One of the spin bikes was replaced.

Views of South Parkade Ramp
