**RESERVE FUND REPORT  
FOR  
RENAISSANCE PLACE  
EDMONTON, AB  
JANUARY 2021**

Board of Directors  
Renaissance Place Condominium Association,  
9918 – 101 Street,  
Edmonton, AB

January 21, 2021

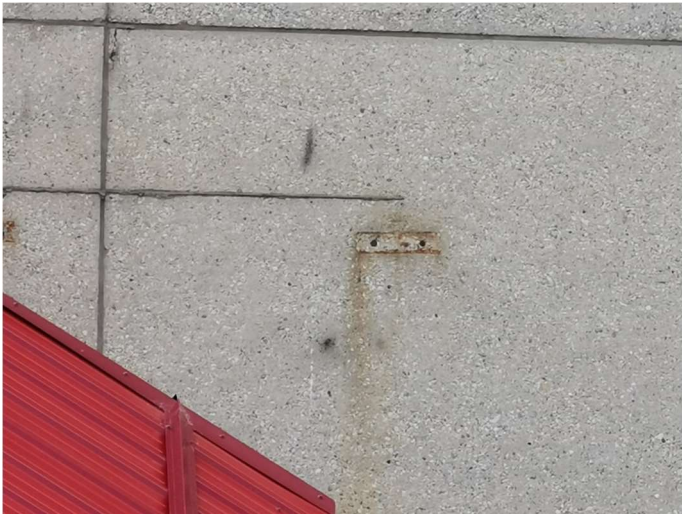
- **Building Envelope** – It was reported that minor cracking in the building envelope curtain walls was observed. The architect who designed the building has been contacted to survey the envelope and make initial recommendations if needed.

Views of Cracks in Building Envelope (East)

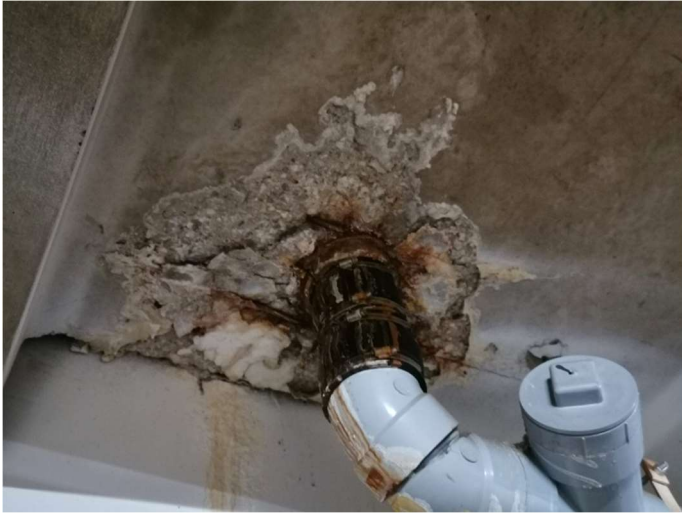
- **Foundation & Parkade** – The foundation and parkade has received repairs over the last several years. The worst areas have been repaired and now the parkade is routinely monitored and repaired. Further repairs will still be required going forward, given the age of the property and the condition of the parkade.

Parkade: Views of Previous Damaged Areas

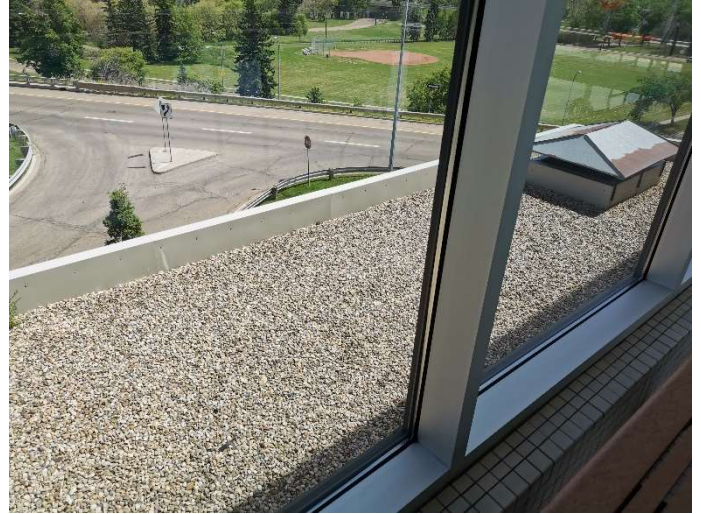
- **Roof** – It was reported that there is a leak in the roof beside the pool facility, which is to be repaired soon. No allocation to the cash flow forecast has been made for this item at this time, as it is presumed that this may be repaired as part of operations and the parkade budget (please see above under Foundation & Parkade).

View of Roof Adjacent to Pool Facility (Main Floor)

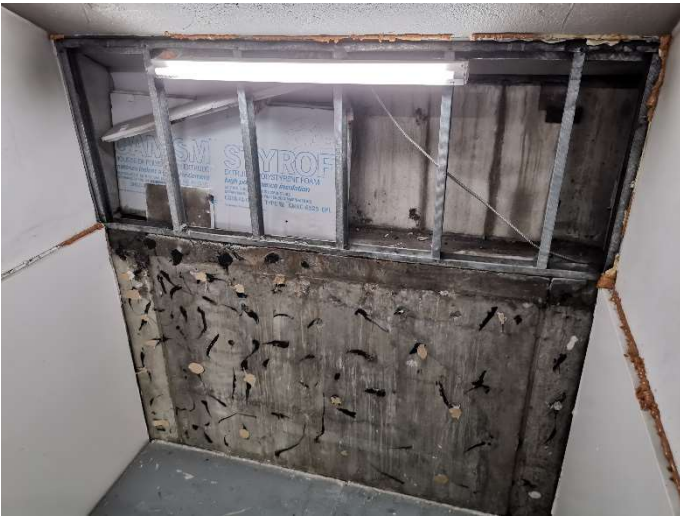
View of Leak in Roof of Pool Facility

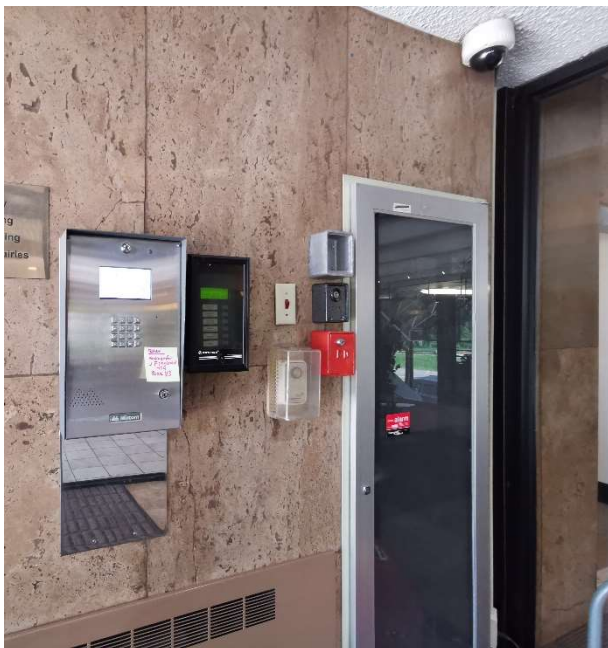
Access Panel and Fire Alarm Panel

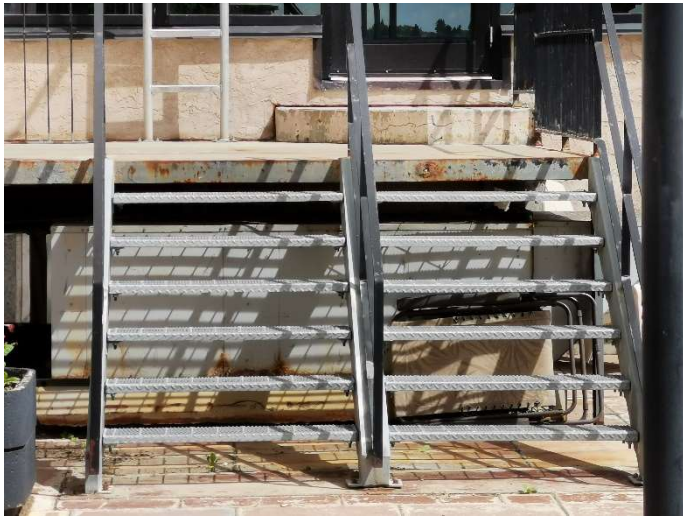
View of Courtyard – Metal Stairs and Makeup Air Unit (Smoke Removal)

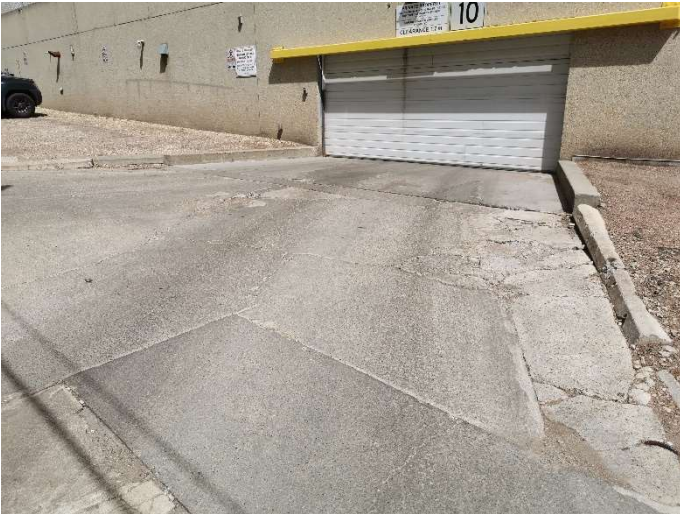
View of North Parkade Ramp
