**RESERVE FUND REPORT  
FOR  
RENAISSANCE PLACE  
EDMONTON, AB  
JANUARY 2021**

Board of Directors  
Renaissance Place Condominium Association,  
9918 – 101 Street,  
Edmonton, AB

January 21, 2021

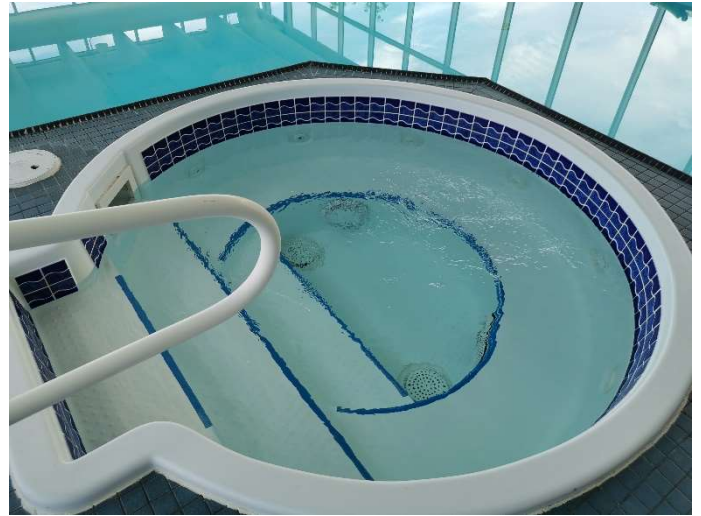
- **Windows & Balcony Door Program** – The final phase of replacements was completed in 2018.
- **Flooring, Lobby** – The lobby flooring was replaced in the last couple of years.
- **Pool Facility** – The hot tub was recently replaced. There is currently a leak from the hot tub into the parkade. Please see above under Foundation & Parkade.
- **Sauna Facility** – The walls and ceilings of the sauna room have been replaced.
- **Plumbing System** – Sections of the horizontal plumbing systems have been replaced, and this program of replacement of sections of plumbing is carried out annually.
- **Garage Doors** - Two of the door motors and control operators were recently replaced.

Swimming Pool Facility – View of Hot Tub

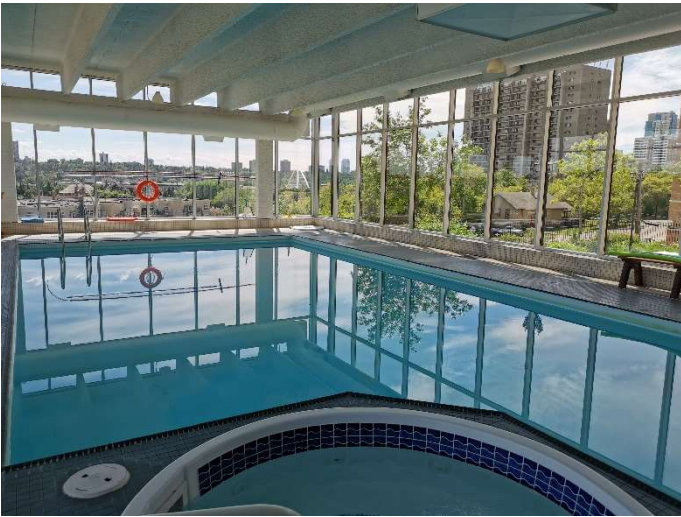
- **Swimming Pool Facility** – The Board intends to implement a renovation/refurbishment project for the pool facility. This would generally include, but is not limited to, pool liner replacement, replacement of the pool deck and shower area as needed or completely, and repair/replacement of the pool facility windows as needed or completely. A preliminary budget of \$100,000 has been allocated to 2022 for this project.

Swimming Pool Facility

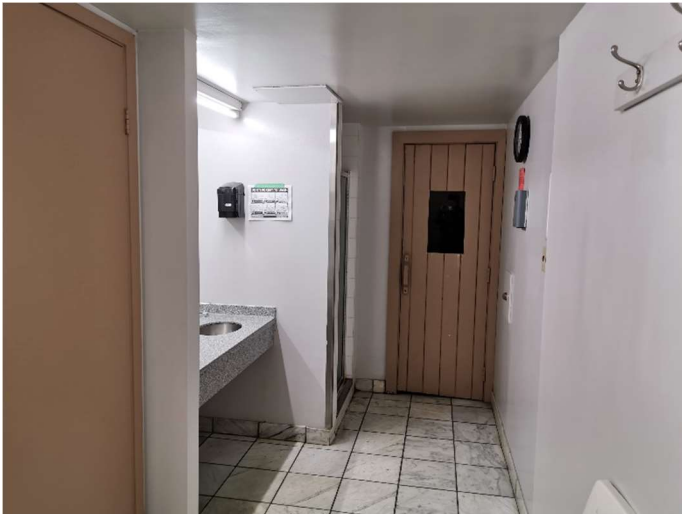
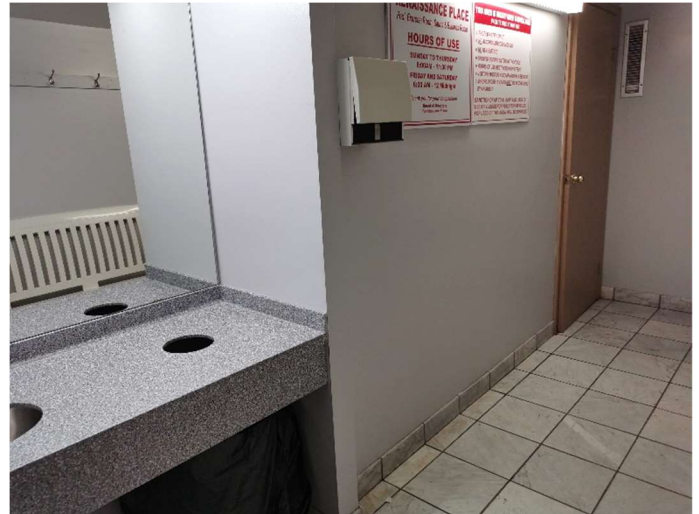
Amenity Areas – Change Rooms

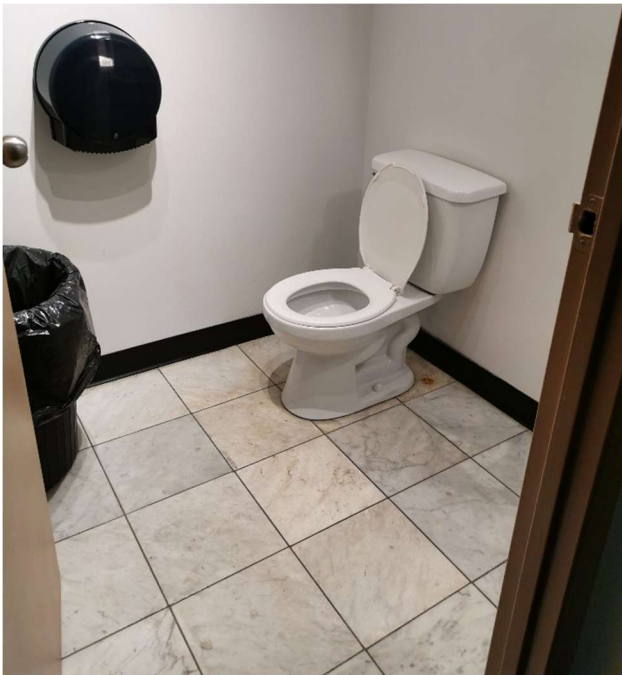
Amenity Area – Washroom

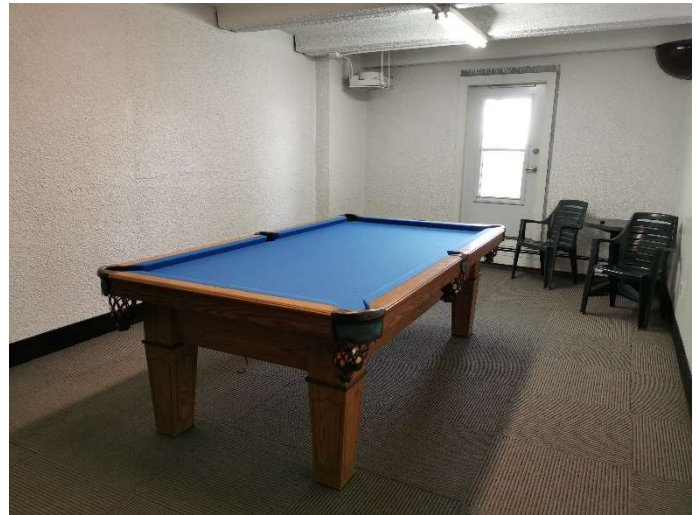
Amenity Area – Billiards Room

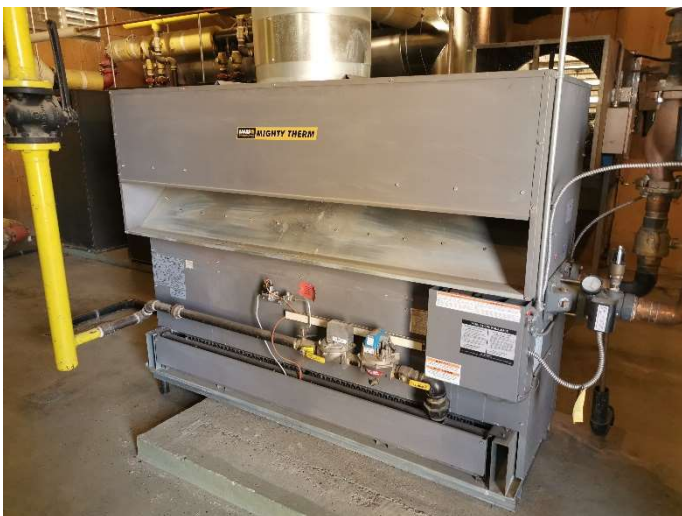
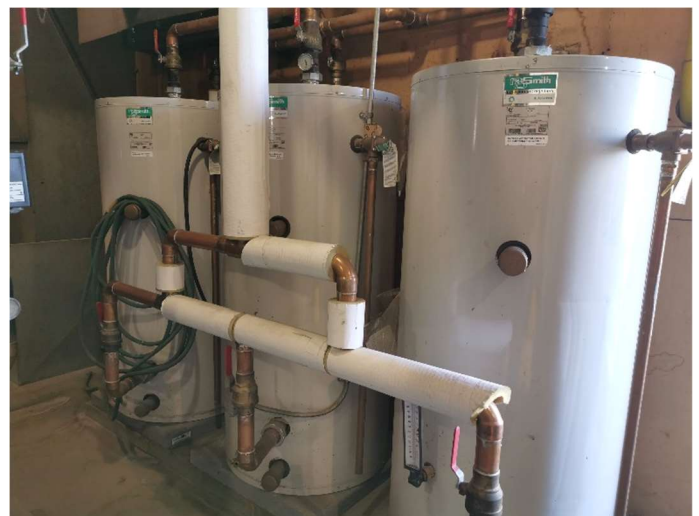
View of Laars Boiler (Domestic Water Heating)

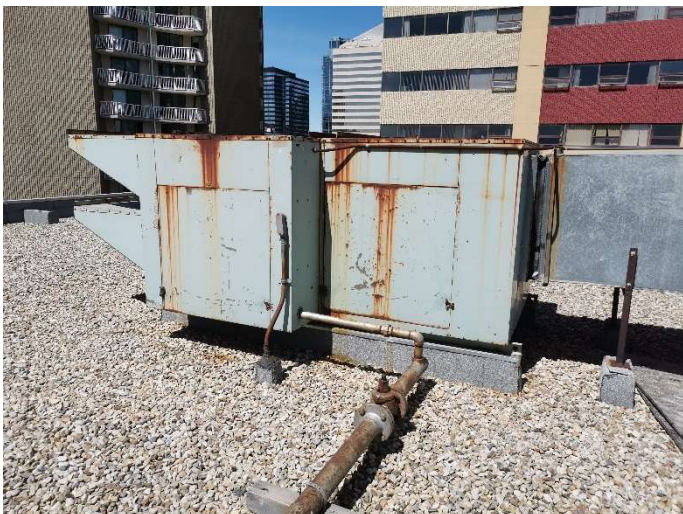
Makeup Air Unit, Example (Smoke Removal)

Makeup Air Unit, Example (Serving Hallway)

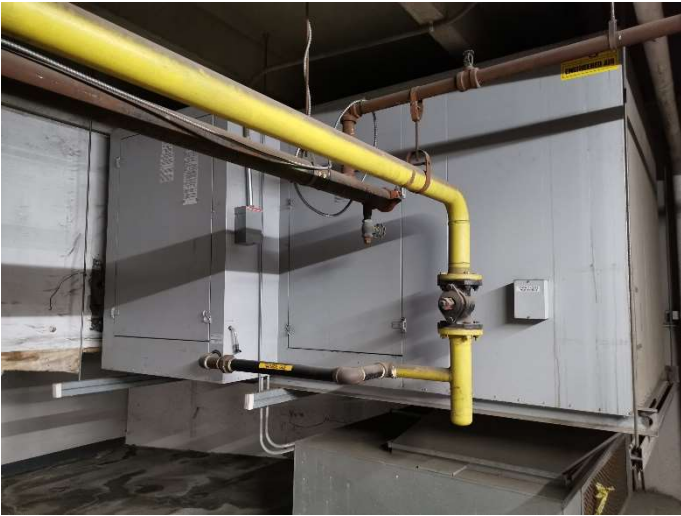
Makeup Air Units – Parkade

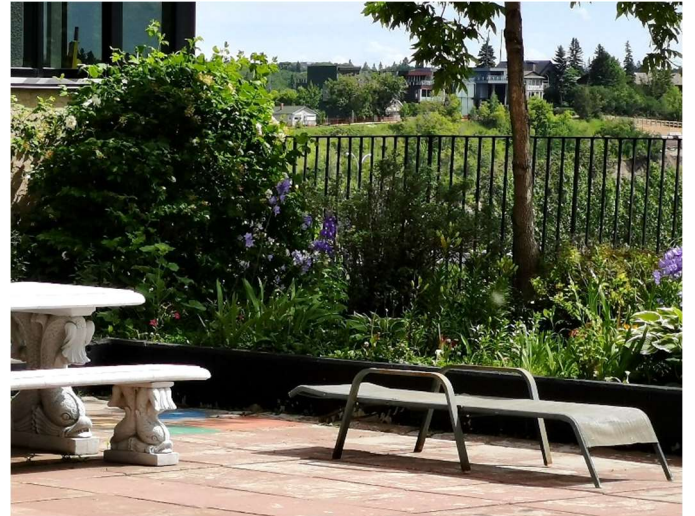
Metal Railings

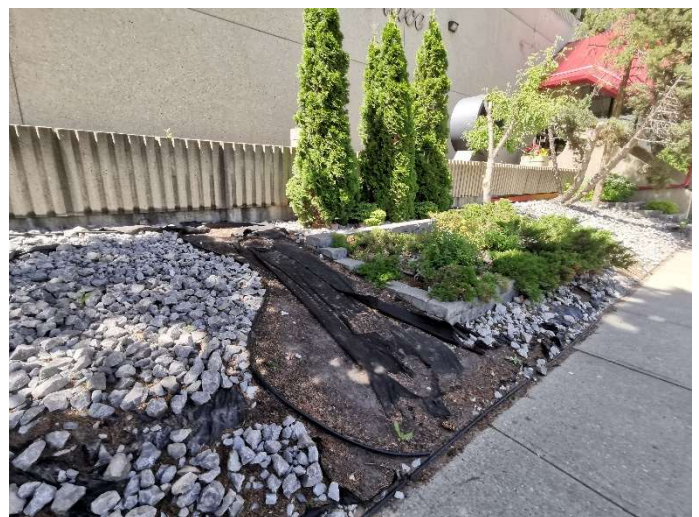
Views of Hard and Soft Landscaping (Front)
